Ferrocement Roof Reinforced with Fiberglass

Abstract

Keywords: Roof Tile, Ferrocement, Fiberglass

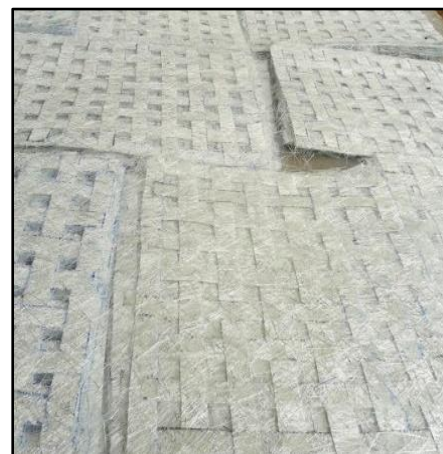
Figure 1. Alternating Fiberglass Placement in Each Layer

Fiberglass preparation: the fiberglass was cut into sizes of $38 \times 2 \text{ cm}^2$ and $29 \times 2 \text{ cm}^2$, then woven by placing the alternating strands of $38 \times 2 \text{ cm}^2$ size first, with a spacing of 2 centimeters between each strand along the length. Subsequently, the strands of $29 \times 2 \text{ cm}^2$ size were placed with a spacing of 2 centimeters between each strand along the width, as illustrated in Figure 1.

Then, it was compacted evenly and firmly. The prepared fiberglass was placed on the mortar, following the illustration in Figure 1 (1 layer of fiberglass, 1.5 cm thick mortar layer). Another

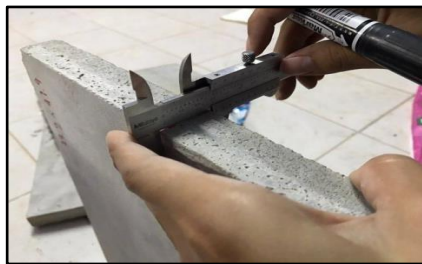
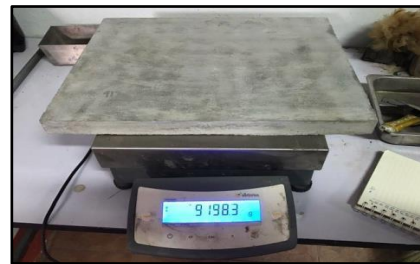
Figure 3. Density Testing of Test Samples

Measurements were taken at both edges and the center to determine the average values for the thickness, width, and length of the tiles on all sides, three times on each side. The density value of the test samples was obtained by measuring the average value, as demonstrated in Figure 3.

1. After a curing period of 28 days, the density testing of manufactured roof tiles was conducted.

A study of the density properties of fiberglass-reinforced ferrocement roof tiles revealed that the roof tiles reinforced with 1 layer of fiberglass had the highest average density of $2.13 \times 10^4 \text{ kg/cm}^3$, while the roof tiles reinforced with 5 layers of fiberglass had the lowest average density of $2.08 \times 10^4 \text{ kg/cm}^3$. A study on the width and length usability of roof tiles revealed that roof tiles reinforced with 5 layers of fiberglass had an average width usability of 33.2 cm

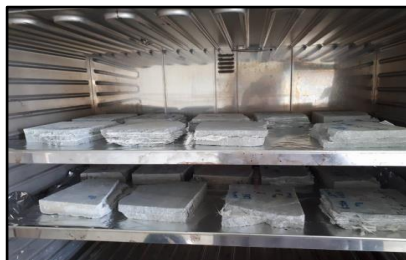
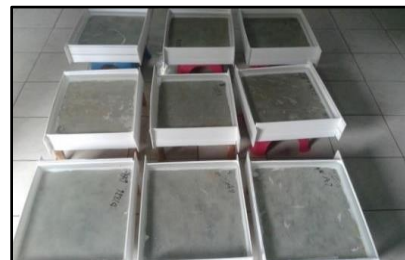
Figure 4. Water Absorption Test

2. The width of each tile was measured using a measuring tool with a precision of 0.1 cm. The average value was calculated, and the results of the tiles were reported.
3. The water absorption test was performed using six test pieces from the tiles that were tested for

breaking strength, with each piece weighing no less than 1,000 g. The test was conducted for 24 hours at room temperature. The results of the test were reported, as illustrated in Figure 4.

A study on the water absorption of fiberglass-reinforced ferrocement roof tiles found that roof tiles reinforced with 1 layer of fiberglass had the lowest water absorption, with an average water absorption of 5.32%. On the other hand, roof tiles reinforced with 5 layers of fiberglass had the highest water

absorption, with an average water absorption of 6.37%.

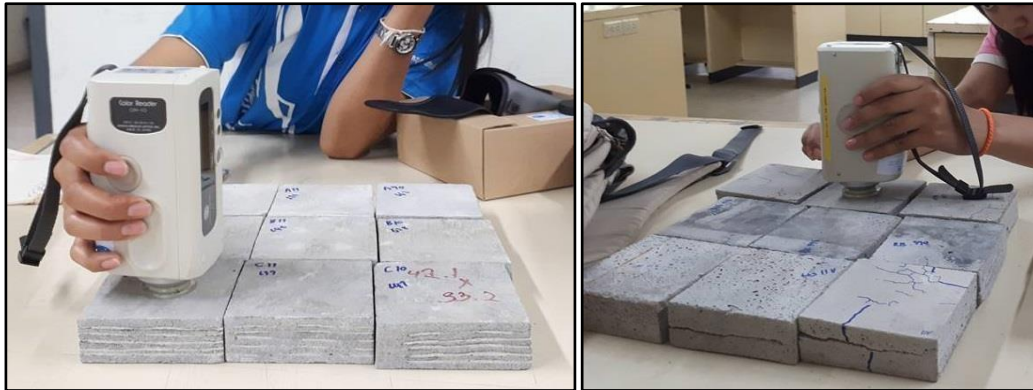
Figure 5. The Heat Resistance Test

5. The heat resistance test was conducted by subjecting the test tiles to a burning process in an external furnace at a temperature of 600°C for a duration of 2 hours. The test involved observing the degree of bending, surface texture, odor, and color changes of the test tiles that occurred after the burning process. The test results were recorded, as shown in Figure 5.

A study on the heat resistance properties of fiberglass-reinforced ferrocement roof tiles during combustion revealed that the tiles reinforced with 5 layers of fiberglass experienced the least amount of cracking (small cracks that are difficult to observe unless thoroughly inspected, with a width of approximately < 1 mm and a length of 120 mm). The tiles reinforced with 3 layers of fiberglass exhibited slightly more cracking (small cracks that were difficult to observe unless thoroughly inspected, with a width of approximately < 1 mm and a length of 180 mm). However, the tiles reinforced with 1 layer of fiberglass showed the most significant cracking (visible cracks with a width of approximately < 3 mm and a length of 250 mm). The occurrence of cracking in the concrete was influenced by the rate of load application and temperature. When the temperature of the concrete increased, it expanded, and when it cooled down, it contracted, leading to the formation of cracks.

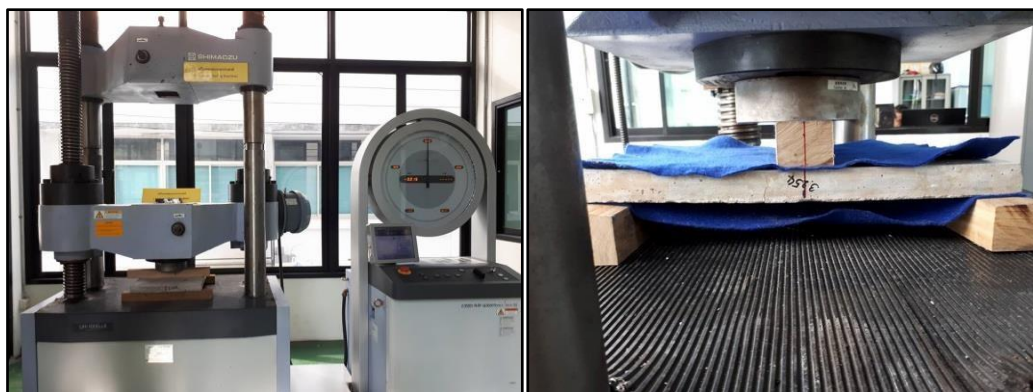
Figure 6. The Tile Breaking Strength Test

The tile-breaking strength test was conducted as follows: A total of six sample tiles were taken for testing. The force was incrementally applied uniformly until the tiles were broken. The applied

force was recorded as the tile breaking strength for each tile, and the minimum required breaking strength for each tile was calculated as shown in Figure 6.

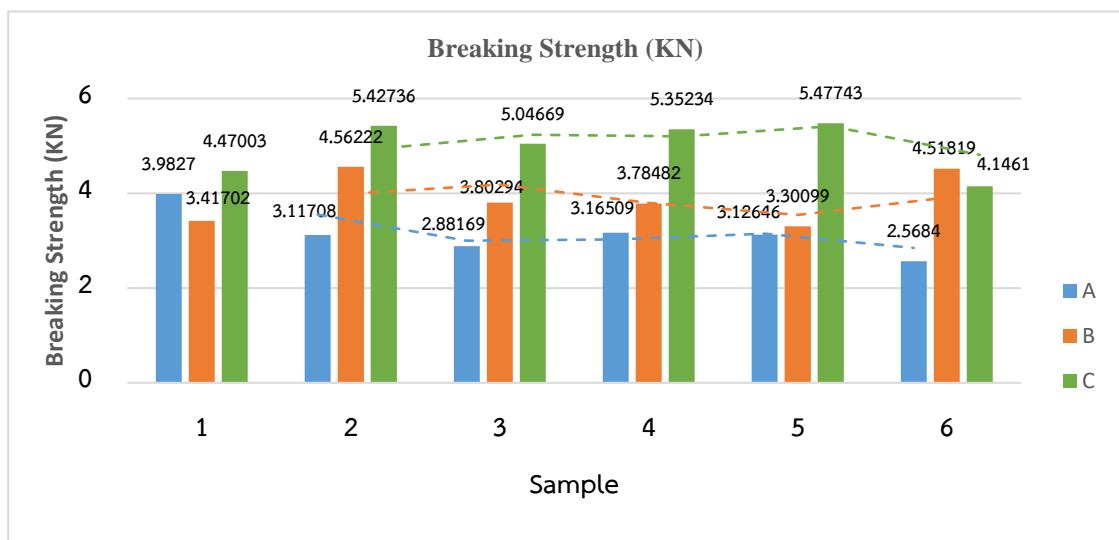
Figure 7. The Breaking Strength of Fiber-Reinforced Ferrocement Roof Tile

It was found that the ferrocement roof tiles reinforced with 5 layers of fiberglass had the highest average breaking strength compared to other variations. The tiles reinforced with 2 layers of fiberglass and 1 layer of fiberglass had the lowest breaking strength. The average breaking strengths in terms of perpendicular compression were 4.986658 kN, 3.897697 kN, and 3.140237 kN, respectively. All tested tiles exhibited breaking strengths higher than the industry standard specified in TIS 535-2556.

The fiberglass-reinforced ferrocement roof tiles, manufactured for the study, exhibit a consistent average density. This can be attributed to the fact that the primary mass of the test specimens is composed of mortar, while the supplementary fiberglass reinforcement has a relatively lower mass. These observations are in accordance with the research findings of Fahmy et al. (2012). The five-layered fiberglass-reinforced ferrocement roof tiles exhibit the highest water absorption. This leads to the formation of voids between the mortar matrix, which are then filled with infiltrating water. It is evident that increasing the number of fiberglass layers enhances water absorption. According to the load-bearing tests, the five-layered fiberglass-reinforced ferrocement roof tiles demonstrate excellent heat resistance and exhibit the highest breaking strength. This is attributed to the reinforcing properties of fiberglass, which significantly contribute to its overall strength. These findings are consistent with the research conducted by Amornpunyapat et al. (2021). The roof tiles also demonstrate high tensile strength and meet the industry product standards specified in TIS 535 - 2556.
