A Machine Learning Approach for Pavement Crack Detection and Classification

Abstract-Pavement cracking, a common issue affecting road infrastructure, significantly impacts road performance and longevity. This article employs MATLAB software to process pavement crack image detection, aiming at a machine learning approach for pavement crack detection and classification. A comprehensive model is utilized for categorizing various cracks and evaluating detection confidence. Additionally, a dedicated crack segmentation network is employed to achieve precise pavement crack segmentation. This approach incorporates advancements that improve precision in crack classification and segmentation. Based on the segmentation results, computations were performed to determine the length of linear cracks and the area of alligator cracks. Research findings demonstrated exceptional accuracy in recognizing block cracks, alligator cracks, transverse cracks, and longitudinal cracks. Notably, longitudinal and transverse cracks exhibited high detection rates, while alligator and block cracks have lower detection rates.

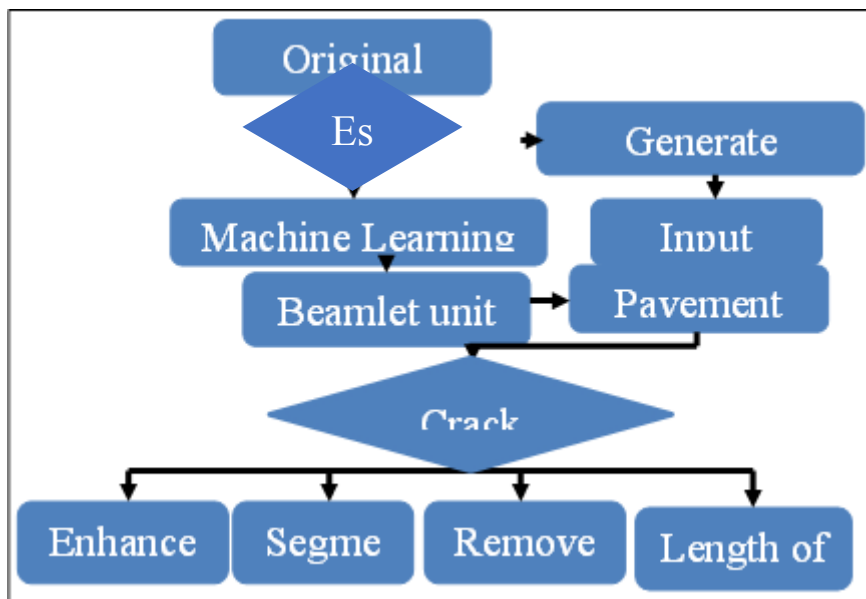
Machine learning approach can be used to identify images based on pavement crack features. Figure 1 shows the fundamental method

Figure 1. Processing steps algorithm flowchart

Asphalt pavement crack detection was performed by using the steps of image enhancement, segmented image, thresholding, eliminated denoising processing, and image improvement according to the algorithm flow (figure 1). The

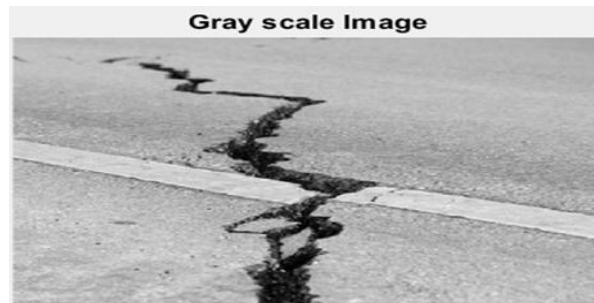
Figure 2 Original of longitudinal crack image

A single longitudinal crack was initially detected in Figure 2. Image processing techniques were employed to enhance visibility and reduce noise, resulting in a clear fracture edge for precise detection and classification. The grayscale image in Figure 3 simplified subsequent processing steps. An image enhancement technique improved fracture details (Figure 4), followed by segmentation using a thresholding technique (Figure 5). Denoising further improved accuracy (Figure 6).

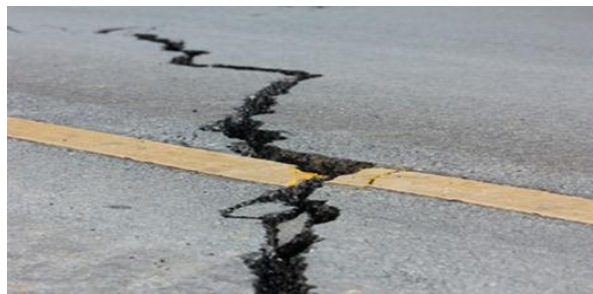
Figure 3 Gray scale of longitudinal crack image

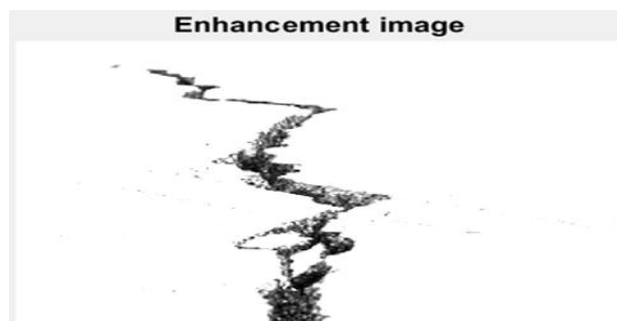
Figure 4 Enhancement of longitudinal crack image

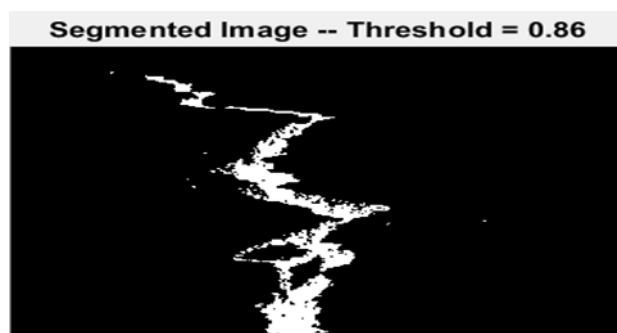
Figure 5 Segmented of longitudinal crack image and thresholding

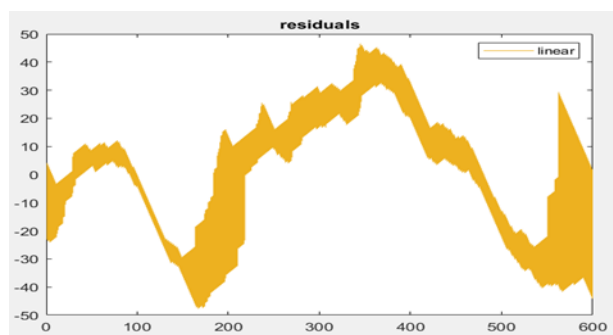
Figure 14 Crack length result for transverse crack

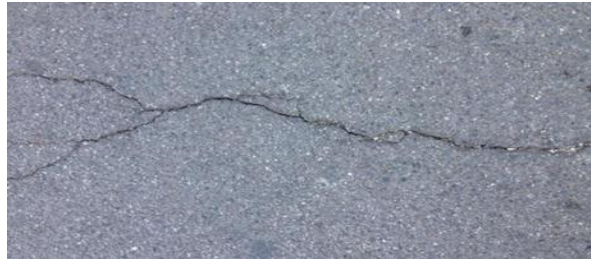
Figure 16 Original of alligator crack image

The first crack image (Figure 16) displayed an alligator fracture with four branches. Efficient techniques, including segmented image thresholding, denoising, and image enhancement, produced a distinct depiction. A grayscale image (Figure 17) was created for processing, and image enhancement (Figure 18) further highlighted crack features.

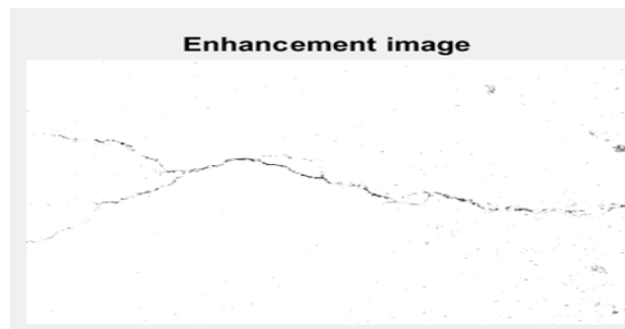
Figure 18 Enhancement of alligator crack image

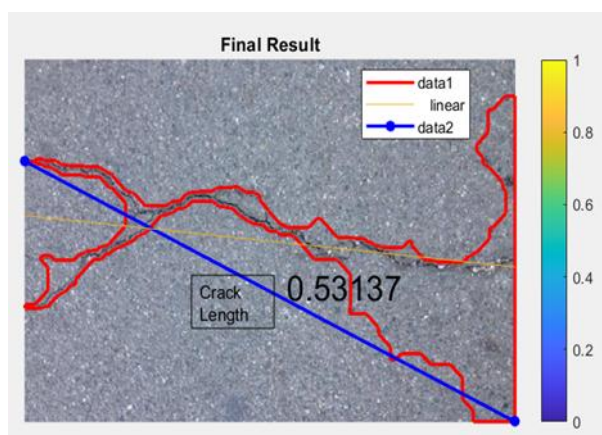
Figure 21 Crack length result for alligator crack

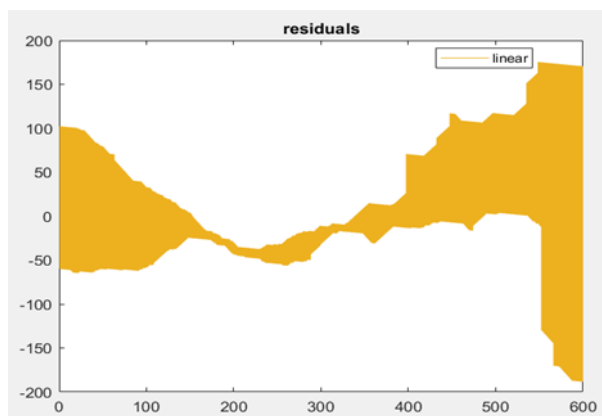
Figure 22 Residuals result for alligator crack

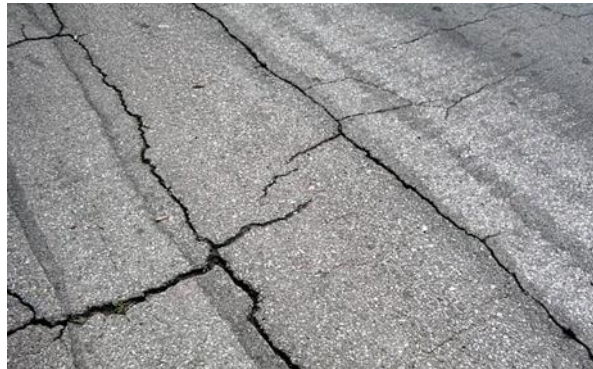
Figure 23 Original of block crack image

For block crack detection, the original image was converted to grayscale (Figure 23), and image enhancement (Figure 24) improved fracture details. Segmentation with a threshold value of 0.84 m (Figure 25) separated the fracture sections. Denoising (Figure 26) eliminated noise.

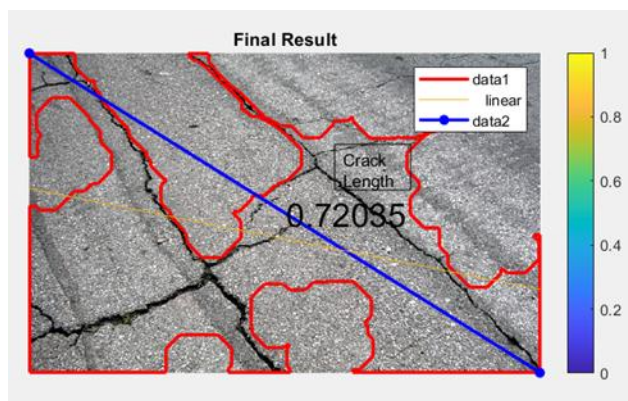
Figure 28 Crack length result for block crack

The block crack was determined to have a length of 0.72035 m and a crack angle of 15° using the Machine Learning Approach. Table 6's categorization findings illustrate that the fracture is a block crack.

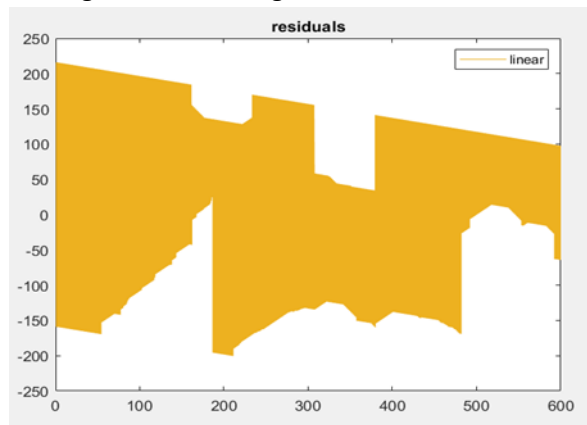
Figure 29 Residuals result for block crack
